360° Test Labs has been retained to ascertain whether certain circuitry changes to fluorescent lamp electronic ballasts reduce or eliminate an overheating problem whereby a plastic shroud over the lamps melts at the ends of the lamps.

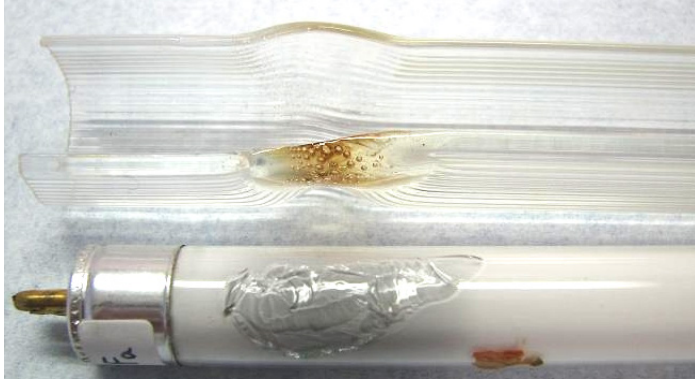
At left is fixture 5F (all the failed fixtures were named 1F through 7F to keep lamps, shrouds and fixtures together with their original parts).

Note the appearance of chipped glass; on all bulbs showing this chipped area, this portion of the bulb was in direct contact with the brown, burned spot of the plastic shroud.

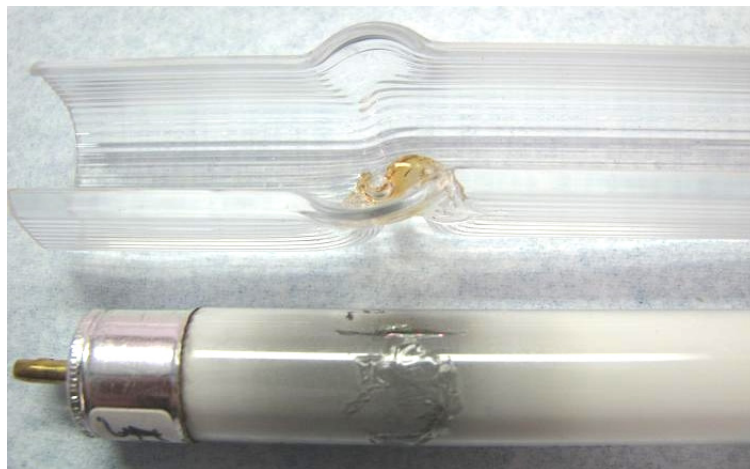
At left is fixture 7F, with the same chipped glass appearance but in addition, an obvious crack in the glass envelope.

The plastic shroud was completely melted onto the glass of this bulb and was difficult to remove—and was possibly the catalyst that caused the this crack.

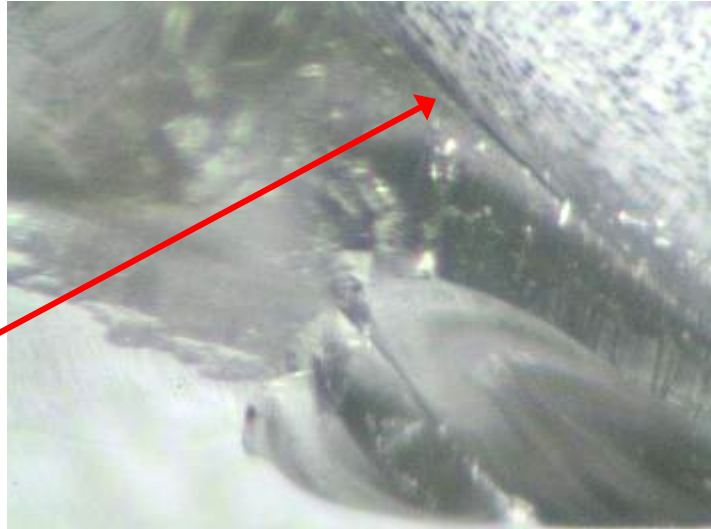
The failed tubes exhibited what appeared to be chipped glass at the areas where the plastic shroud had melted. However, closer examination under the microscope reveals a swirl pattern characteristic of melted glass, as seen in the photo to the right.

Melting can be seen as the line running from top right-center of the photo, to the middle of the right edge of the photo.

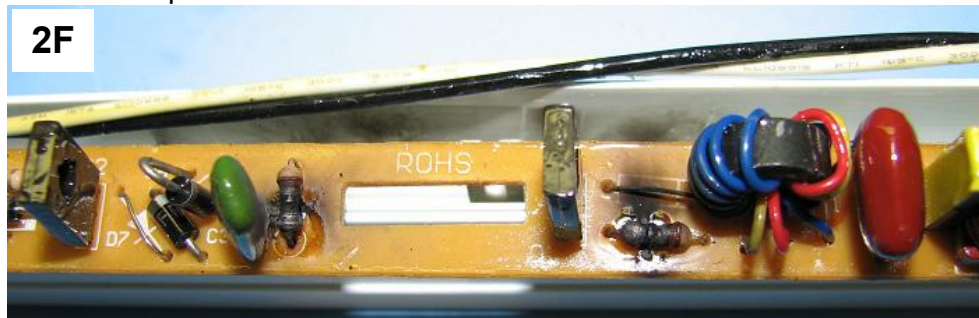
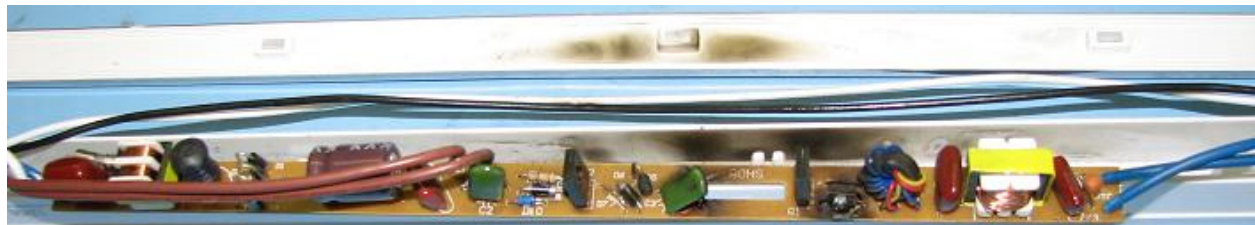
Two fixtures had burned electronic parts on the PC board, as well as their 1-ampere fuse having been opened, apparently due to overcurrent. The fuses on fixtures with no burned parts were all

found good and those fixtures worked again once the tube was replaced. The picture below shows the burned components on fixture 2F.

Fixture 5F is shown above; note the smoke smudges on the top cover of the fixture case. The same resistors were burned on this PC board as found on fixture 2F's board.

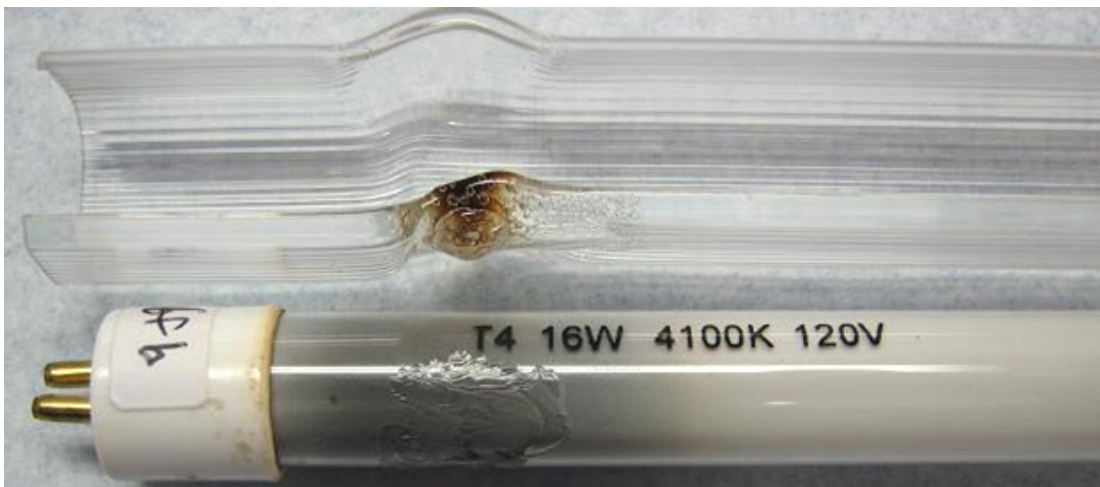
Fixture 6F was found with a late-type bulb installed – with white end caps; all the bulbs in the other six fixtures had bright aluminum end caps. Besides the different end caps, the light “color” of the white-cap tubes is stamped 4100K on the tubes as seen below, whereas the “color” of the older tubes is 3400K. This white-capped tube, shown in the photo below, exhibits the same chipped-glass failure mechanism as the older aluminum end-cap tubes.

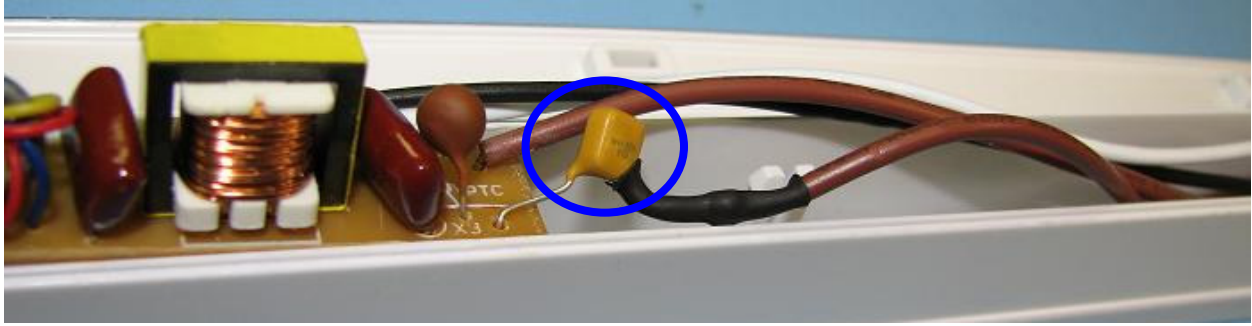
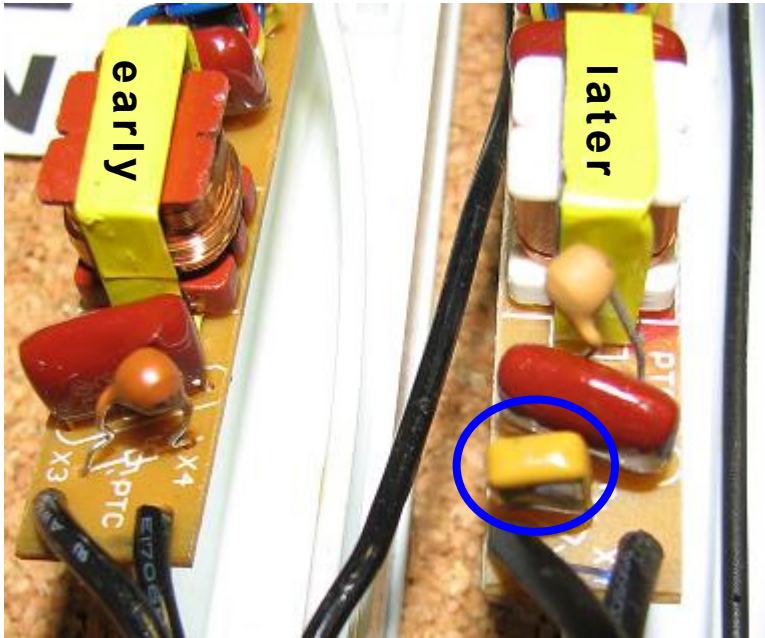
Fixture 7F was found to have been modified at some time by the addition of the same PTC that has been permanently added to all the new fixtures; yet, it's tube still got hot enough to melt the shroud, as seen in the picture above of fixture 7F. The below picture illustrates how the PTC was added to fixture 7F. It is not clear whether this wiring technique is NEC-compliant. However, since the fixtures have plastic cases, there is no danger of this wiring technique shorting.

At left, the photo shows a PC board from an early fixture (left side fixture), with only a high voltage-circuit (HV) PTC. To its right is a late-date code fixture's PC board with both the original HV PTC as well as the added filament PTC. The new PTC is the brownish-orange small rectangular object just above the black wires on the right-hand PC board. The small round brown object above the darker brown oval-shaped capacitor is the high voltage PTC, which is present in all the fixtures. This HV PTC protects the electronic ballast in case the tube will not ignite by increasing its resistance until the multivibrator will stop oscillating.

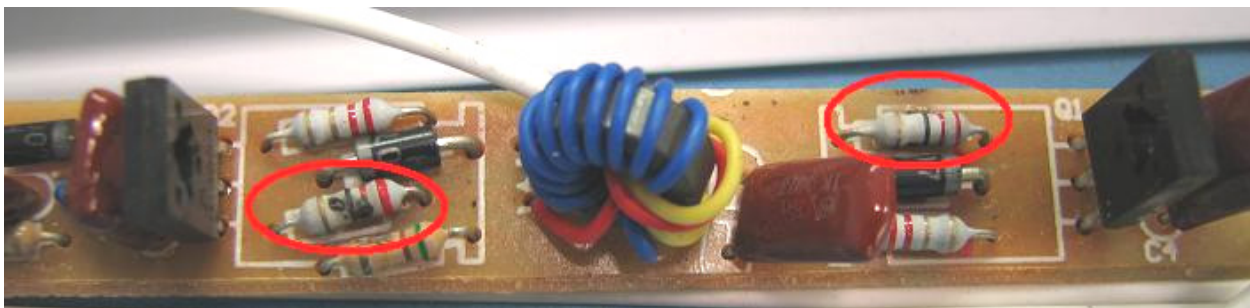
After approximately 3 hours operating continuously at 175 VAC, one 240 volt fixture failed catastrophically, the first such failure; see the photo below.

In this case, it appears that the two multivibrator transistors either overheated or the high AC input voltage exceeded their voltage ratings. One of the transistors failed internally, causing its

associated base current limiting resistor to almost instantaneously burn open, then the other transistor also failed and took out its own base resistor. The two red-circled resistors above show almost no damage other than several small specs of black soot where they instantly burned open. In addition, the edges of each transistor were also sooty, indicating they, too failed almost instantaneously.

The electrical design of the 240 volt ballasts is similar, but not identical, to that of the 120 volt ballasts; one difference is the addition of 0.22 Ohm current limiting resistors at the emitter of each transistor, which can be seen in the photo above (the two devices with the red color bands next to the circled resistors).

The 120 volt ballast design does not contain these emitter current limiting resistors. The failed base resistors shown above perform the same function as R3 and R4 in the 120 volt ballasts, which were the two resistors found severely burned on two of the seven failed fixtures that were provided to 360° Test Labs. However, the similarity of this failure mode between the earlier-failed fixtures and this “surge”-induced failure is likely only that: a similarity.

Note, for example, that the earlier resistor failures evidently occurred over a period of time during which the resistors did not instantly fail, which was the case above where the resistor did not have time to actually burn. In this case, it appears much more likely that the cause of failure was the transistors breaking down due to the high AC input voltage whereas the earlier failures appear to be related to a failure of the fluorescent bulbs, which the multivibrator’s two transistors kept trying to ignite until the transistors overheated and shorted internally.

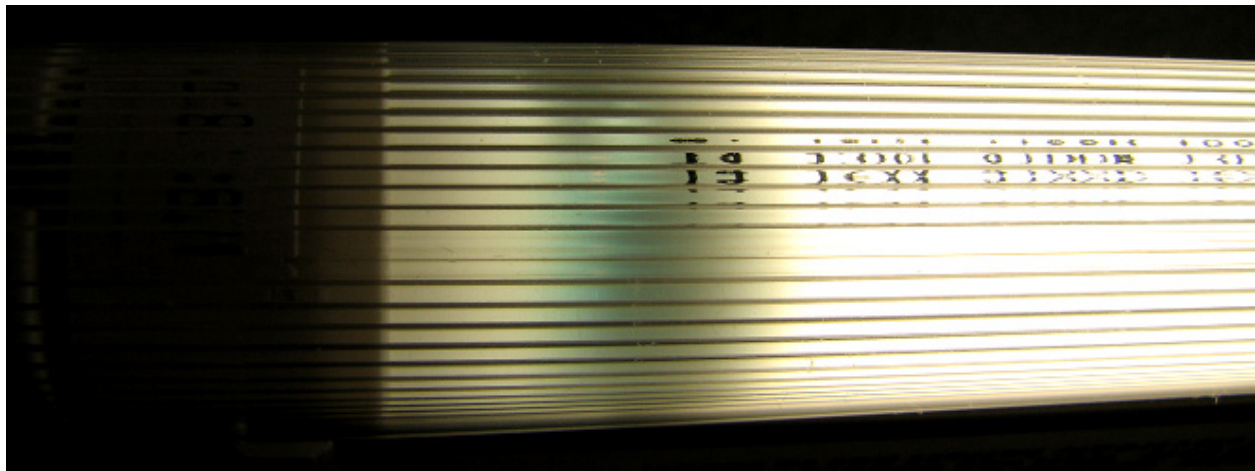
During the 160 VAC test, it was noticed that several tubes showed a slight blue color at either end, as seen in the photo below:

It is unknown what the bluish color signifies, if anything. When tests were first begun on new fixtures, several bulbs exhibited a similar blue or violet glow near the filament but as the end of the tubes darkened, the glow became less visible.
