Introduction:

360° Test Labs has been retained to perform a comparison of electrical / mechanical measurements, and build quality, between motors manufactured by Brand-1 and Brand-2 to address reliability concerns.

Findings:

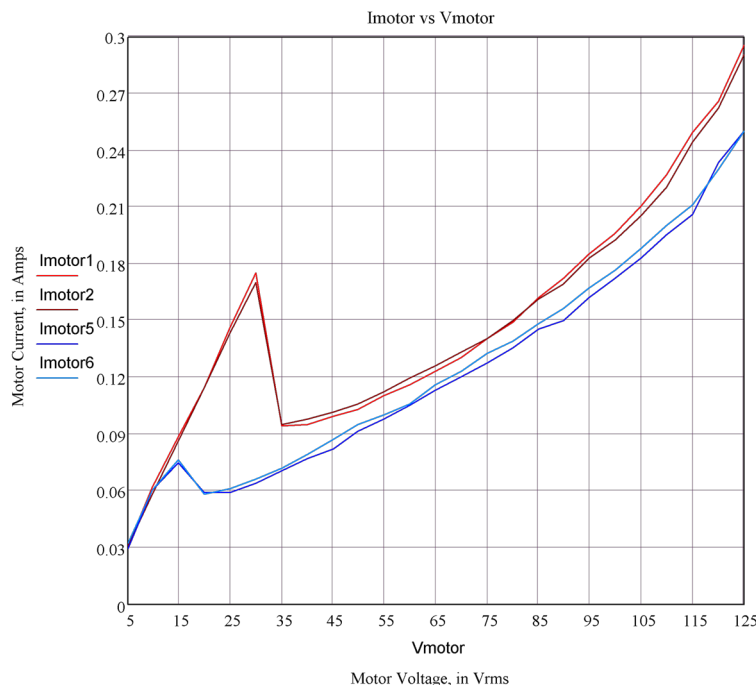
Figure 1 is a graph of motor current versus motor voltage for the 115V motors and Figure 2 is for the 230V Motors. As can be seen the current rises until the motor starts rotating, then the motor current decreases due to the emf of the motor. As the motor voltage increases, the current starts increasing again. What seems like a gradual decay of current from when the motor starts turning is just the resolution of the motor voltage increments.

The Brand-1 motor has a higher degree of drag than the Brand-2 motor and therefore requires a higher starting voltage. The cause of this drag will be discussed later. The current at nominal operating voltages is also higher for the Brand-1 motor due the required increase in torque.

Figures 3 and 4 are graphs of the motor speed in Revolutions Per Minute (RPM) versus the voltage applied to the motor. The performance agrees with Figures 1 and 2 in that a higher motor voltage is required to overcome the “stiction” of the Brand-1 motors.

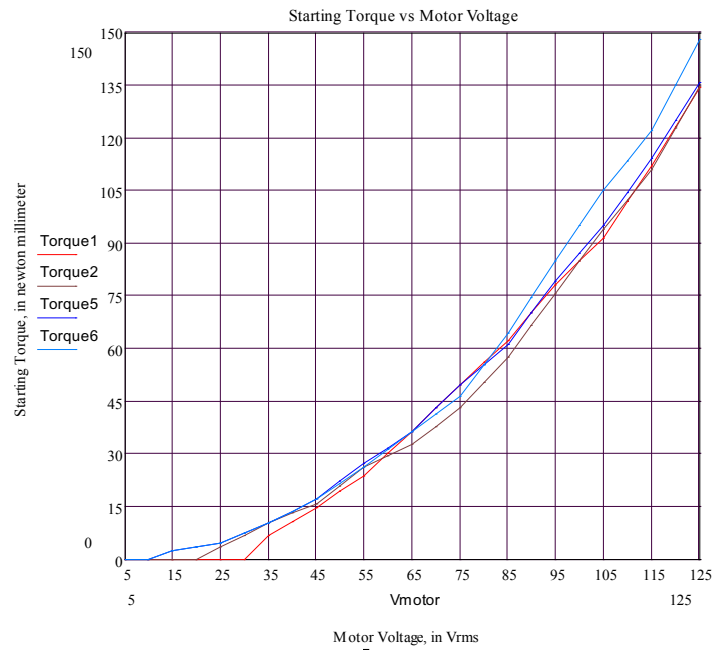
Figure 5

Figures 5 and 6 are graphs of the starting motor torque versus voltage applied to the motor. No significant differences were observed.

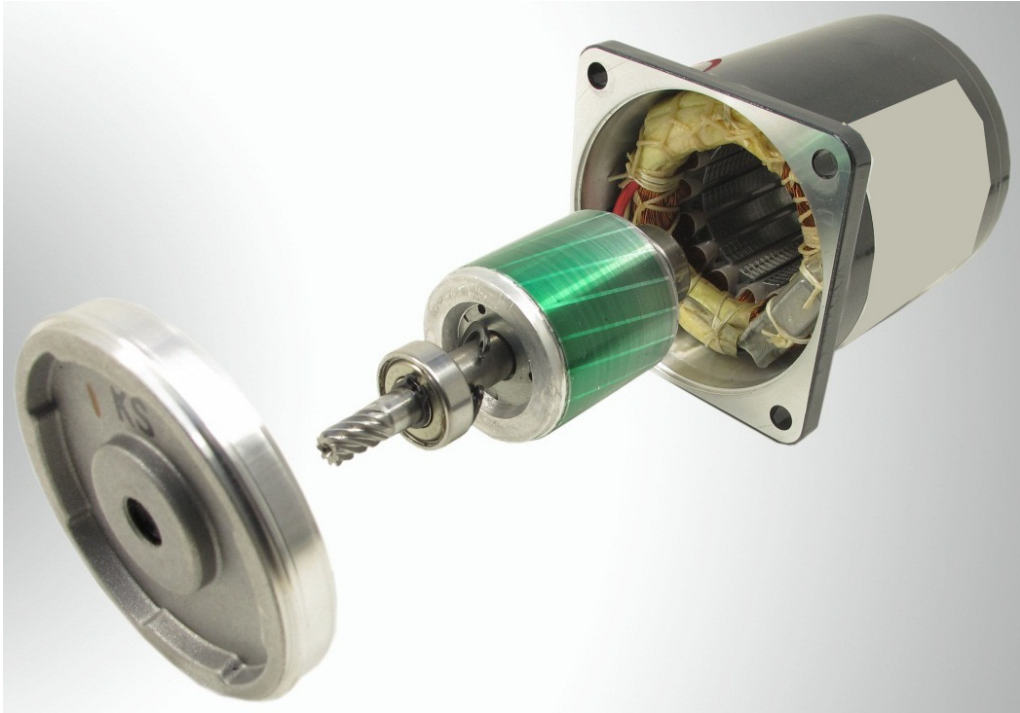
After the motors were fully characterized, the motors were disassembled for inspection using a custom device to minimize damage to the motors. Motors 1, 4, 5, and 7 were selected representing one each from Brand-1/Brand-2 115V/230V. The following four photographs are front and back exploded views of the Brand-2 and Brand-1 motors

Figure 17 Brand-1 Motor

Figure 18 Brand-1 Motor

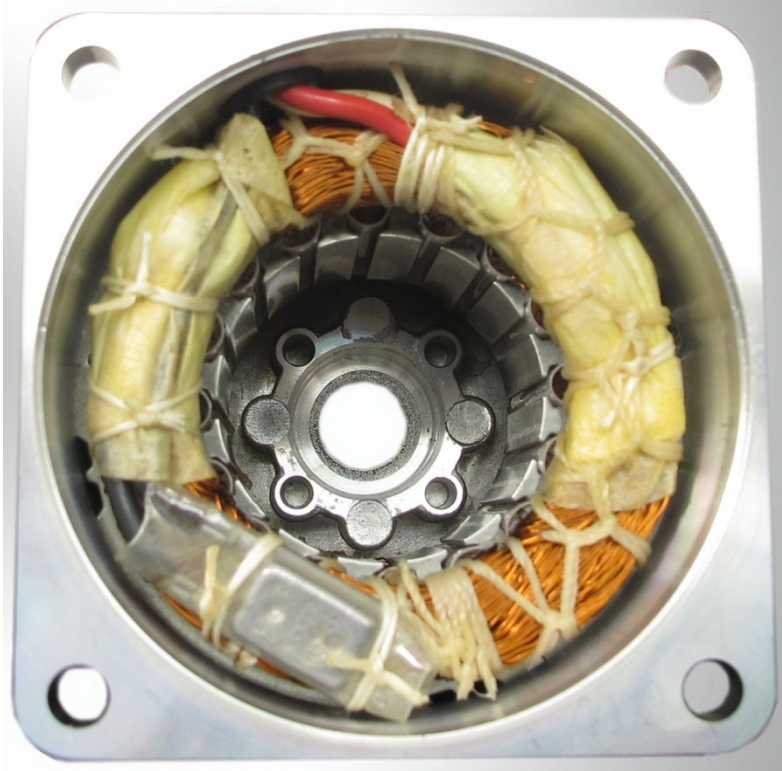
FIGURE 21

Figure 21 is a photograph of the Brand-1 Stator. At the bottom left is the over-temperature protector. The black main lead is crimped to the protector.

Also notice that the Brand-2 “stringing” around the top conductors is more robust as opposed to the hand-tied method used in the Brand-1 product.

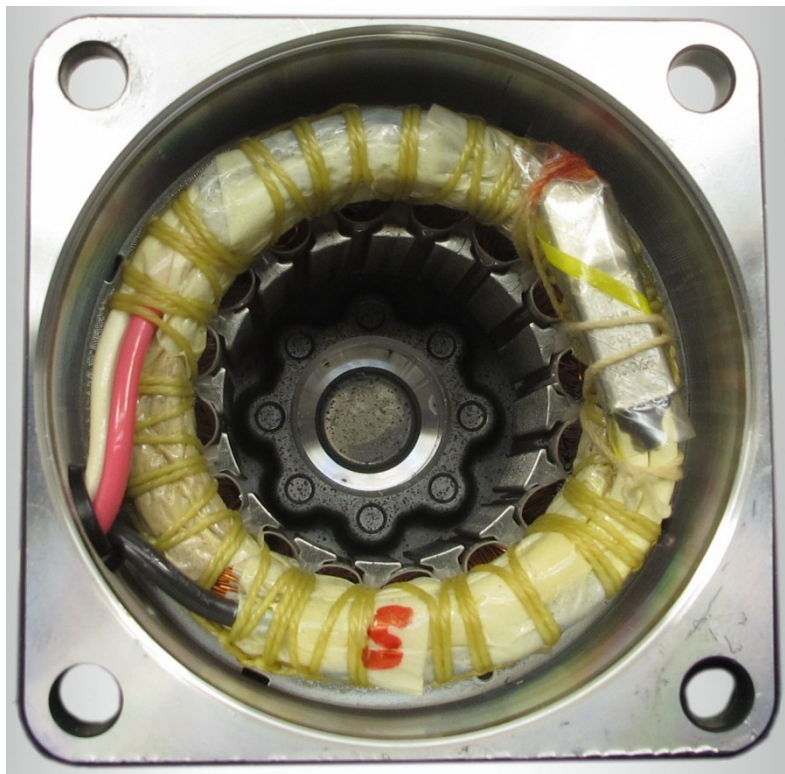
The Brand-2 motor is shown in Figure 22 above. The over-temperature protector, seen at the upper right, has 1.5” leads that are part of the protector and are twisted together with the black main leads and then soldered. A hard plastic tube is then slipped over the joint. This connection is more reliable than a crimped connection with respect to vibration effects.

Although not clear in the photos, the Brand-2 stator has an epoxy coating over the top as extra lead integrity.
