### Introduction:

360° Test Labs has been retained to measure the performance and operating temperature of a solar device solar charger system over a temperature range of +20°C to +80°C, at relative humidity of  $50\% \pm 5\%$ .

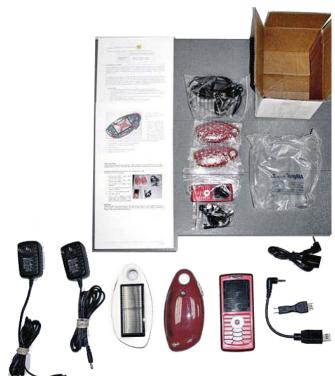
Supplied to 360° Test Labs As shown to the right:

- 1. DXX-XX-XX1 Client solar device Mono Sample (40% charge)
- 2. DXX-XX-XX2 Client solar device Mono Sample (60% charge)
- 3. Two AC/DC 5.5V 400mA mains adapters
- 4. One DC Output testing dongle with polarity markings
- 5. One DC Output adapter tip cable
- 6. One Mini USB tip
- One Virgin Mobile branded UTStarcom PCS1450VMR mobile phone with one UTStarcom 3.7V 900mA BTR1450 Lithium Ion battery

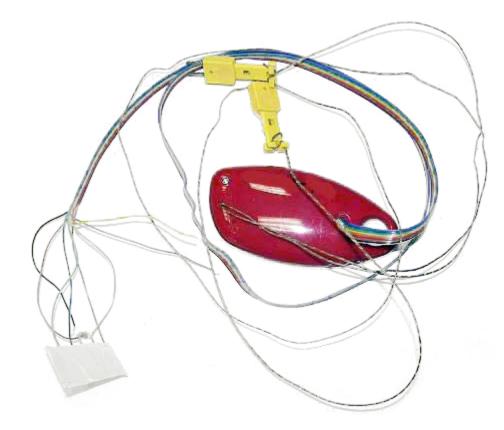
Modified solar device. The ribbon cable is connected to the battery and solar panel inside the case; note that this cable brought was outside the case by omitting the plastic part that pressed on the pushbutton original switch. To turn on the solar device, a thin tool is inserted between the ribbon cable wires into the solar device and onto the pushbutton switch. The two internal thermocouple wires were brought out through a new hole drilled into the case.

The two solar device products were slightly modified by placing thermocouples on the back side of the solar panel and on top of the battery. In addition, wires were added to allow monitoring of the battery and solar panel voltage and current; photos on the following page illustrate the modifications. A small hole was drilled in one end of the red cover to bring out the thermocouple wires but the battery-solar panel wires were fed through the existing hole in the case for the pushbutton on-off switch. To turn on the solar device, a thin tool was inserted through the hole and the pushbutton depressed.

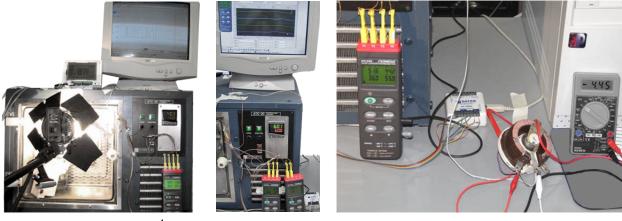
Light Application<sup>1</sup>

T° Monitoring

Load Application

<sup>1</sup> Lowel P2-10 Pro-light 250W, 3200K, Quartz Halogen lamp with barn door attachment

The temperature was then adjusted in 10 degree steps from +20°C to +80°C. Electrical data was recorded continuously by a Dataq DI-158U 4-channel differential data logger. Humidity was controlled by a humidity sensor inside the chamber next to the solar device itself, and was recorded by an Extech 42270 temperature-humidity Datalogger.

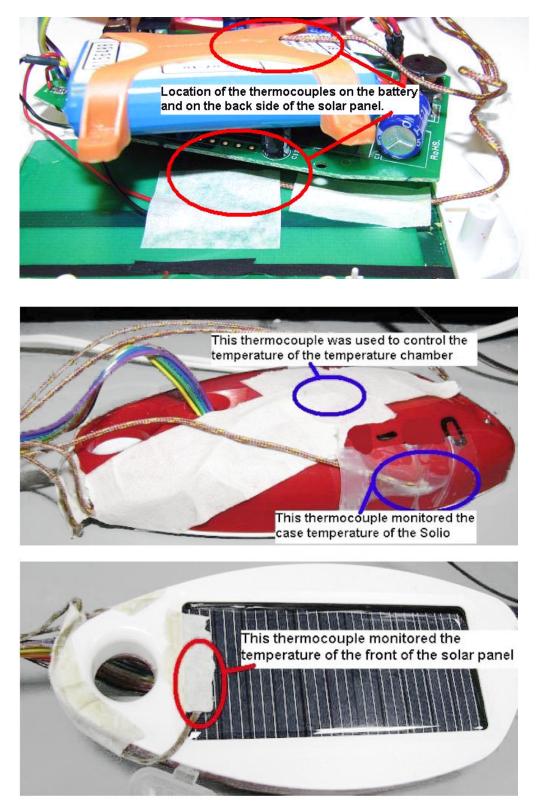
Omega HH309 Datalogger Thermometers were used to record the temperatures in and outside of the solar device under test. The three photos below show where these five thermocouples were positioned.

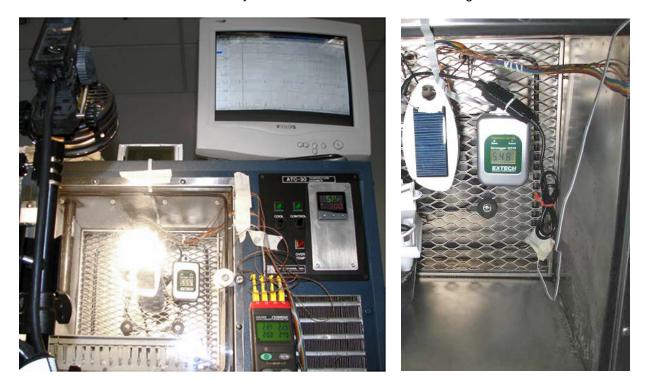
The photos below show the temperature chamber with the solar device under test, the Extech temphumidity recorder to the right, and the voltage charting on the CRT monitor. The gray ribbon cable from the humidity sensor to the external controller can barely be seen in the top center of the picture at right. The tip jack connector is plugged into the solar device then spliced to a longer cable to bring the output of the solar device outside the chamber where it was connected to a resistive load and voltmeter for monitoring of the output of the solar device; this cable is the gray-white ribbon cable seen running along the side wall of the chamber. The electrical data from the solar device's battery and solar panel is carried out of the solar device and chamber by the multi-color ribbon cable on the right side of the chamber.

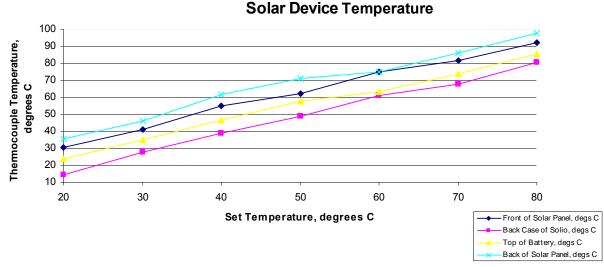
The following chart shows the temperature at each of the four locations on the solar device. As can be expected, the back side of the solar panel was the hottest location, averaging about 15°C hotter than the back of the red case which was not exposed to the lamp. The battery temperature was generally just under 10° warmer than the back case when powering the solar device; but above about +65°C where the solar device turned off its output and stopped drawing current from the battery, then the battery temperature was only a few degrees warmer than the back case.

Note that the temperature of each location on the solar device increases by about the amount of the ambient temperature rise.

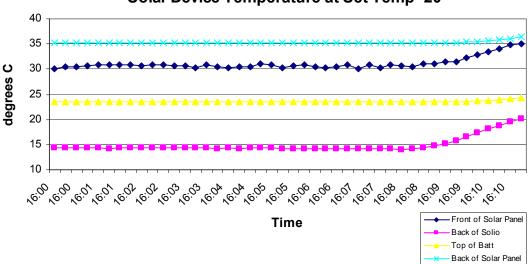
# Solar Device Temperature at Set Temp=20

The following plots show the temperature differential between the four thermocouples mounted on and within the solar device in greater detail. We retested certain temperatures to obtain the best data and so not all temperature plots shown henceforth will be consecutive in time.

In the plot above, it is clear that the temperatures have stabilized for some minutes before data was taken. The Set Temperature of the chamber was then increased to 30°C at about 1608, as can be seen from the climbing traces above.

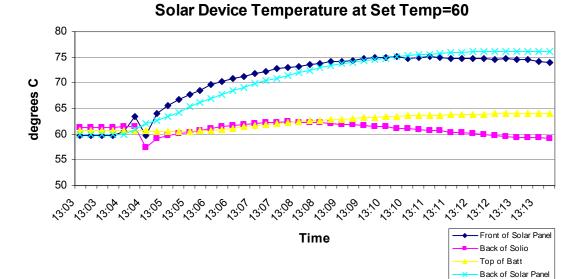
The constantly changing temperatures seen above in the 60°C plot resulted from the solar device shutting down its output load before all temperatures had stabilized. The shutdown occurred at about 1304 as seen above; the sharp jumps in temperature are from opening the temperature chamber door to attempt to turn the solar device's output back on. However, it continued to shut off almost immediately, even with no output load. The solar device continued to charge the battery, however, as shown in the earlier table.
