360° Test Labs has been retained to ascertain whether certain circuitry changes to fluorescent lamp electronic ballasts reduce or eliminate an overheating problem whereby a plastic shroud over the lamps melts at the ends of the lamps.

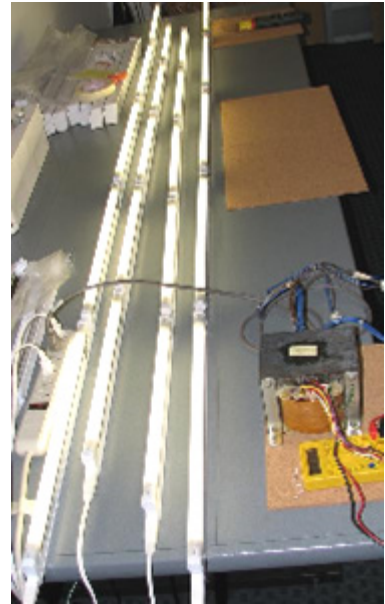
Initially, all twenty fixtures were operated continuously, without power cycling, for 8 hours (pictured at right). The transformer stepped up 120VAC to 240VAC.

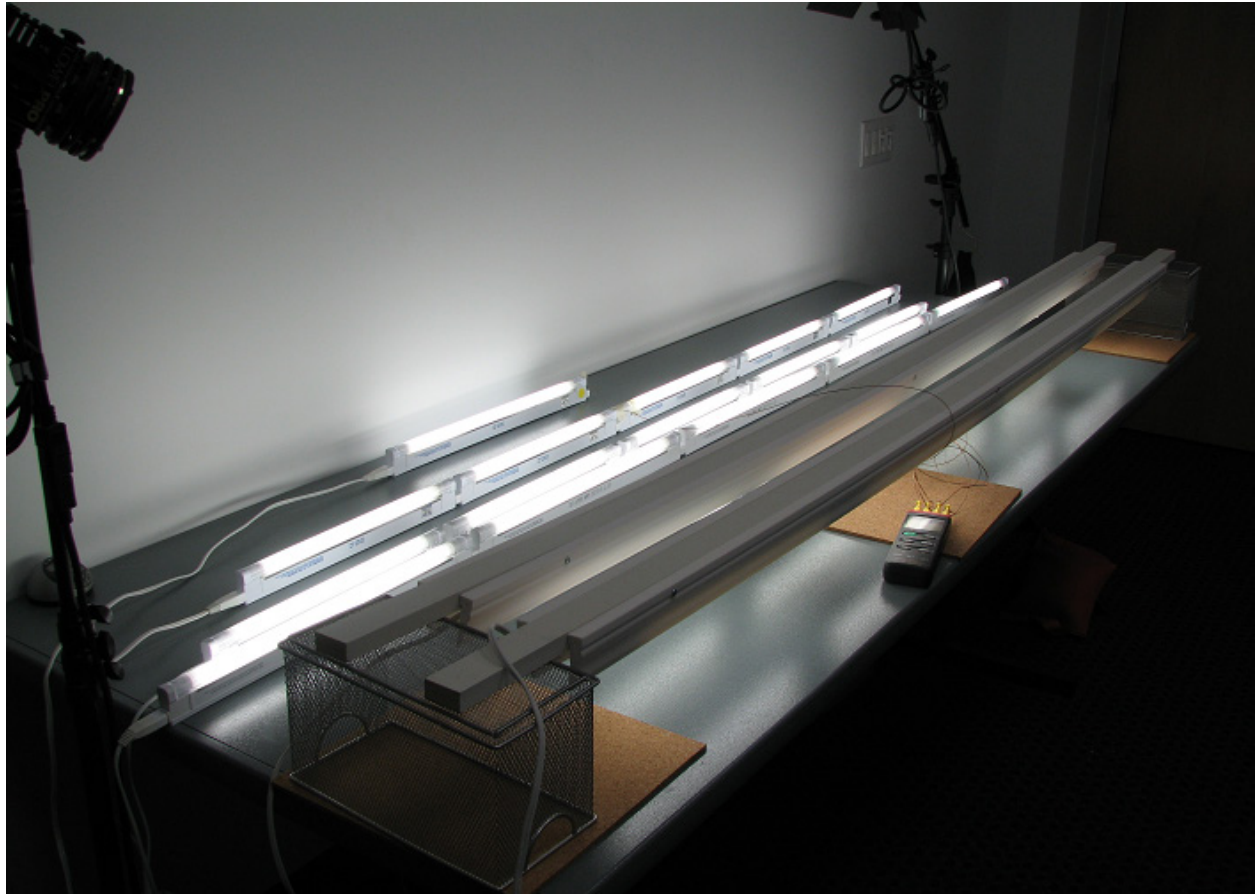
During the initial continuous operation test, several fixtures whose shrouds appeared to become warmer than others were set up for temperature monitoring using a Data Logging Thermometer. Thermocouples were mated to shrouds at the same area where the failed fixtures had melted their shrouds. It was found that when operated continuously, shrouds of several fixtures experienced temperatures as high as 155° F. When cycled, the fixtures did not get as hot, the maximum typical temperature being in the 135° F range.

The fixtures were first operated tube-up; thus, the heat of the fluorescent bulbs essentially radiated to the sides or straight up. When installed into appliances such as a salad bar, the fixtures are typically mounted with the tube down inside a metal channel. This allows the bulb heat to rise and surround the fixture itself, heating the whole fixture. After gathering initial temperature data, the test setup was modified with the addition of two custom fabricated “channels” within which fixtures were mounted. These channels were then suspended with the tubes down; see the photo below. It was found that while fixture shroud temperatures did rise when mounted within the channel, the increase was at most several degrees Fahrenheit.

Temperatures were found to vary considerably both between the various fixtures as well as at either end of the shroud on a given fixture. In addition, the fixtures located at the ends of a “string” of fixtures exhibited lower temperatures at the outer end of the fixture. In general, during continuous operation, the cooler fixtures operated around 140° F at one end or the other; some showed nearly the same temperature at both ends. While cycling, the cooler fixtures operated around 115° to 125° F.

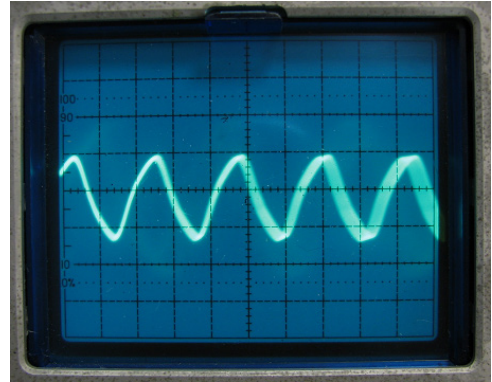
An oscilloscope was used to examine the waveform of an operating 120 VAC, 12W ballast. The multivibrator operates at about 45 kHz and produces an almost-triangle wave; see the photo to the right. The amplitude of the high voltage triangle wave applied to a lit 12W tube is approximately 200 volts peak-to-peak (Vpp). As a tube is being ignited, the voltage rises to 700 Vpp (800 Vpp when one filament is shorted). This immediately drops to 200 Vpp after the tube has fired.

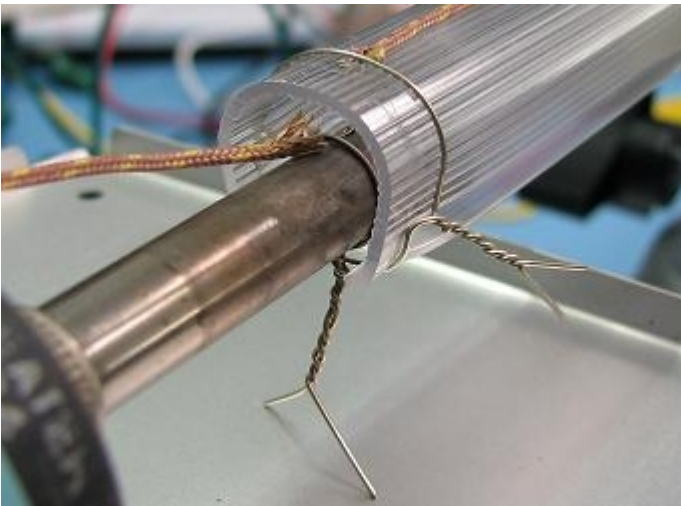
A test jig was set up to simulate an overheating tube to find at what temperature the plastic shroud would soften, blister, and permanently deform; see the photo to the left:
